## COROBRIK (PTY) LTD

## MIDRAND OPERATIONS STORM WATER MANAGEMENT PLAN

AUGUST 2024

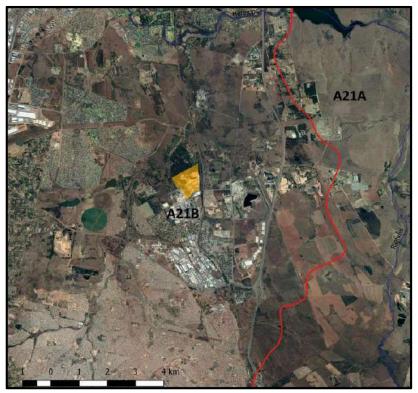
Figure 7: Hydrological Map

Corobrik (Pty) Ltd Midrand is located in the quaternary catchment A21B as shown in **Figure 7**. According to the updated hydrology for South Africa (WR2012; (WRC, 2015)), A21B receives a mean annual precipitation (MAP) of 672 mm and has a mean annual run-off (MAR) of 7.7 million m3.

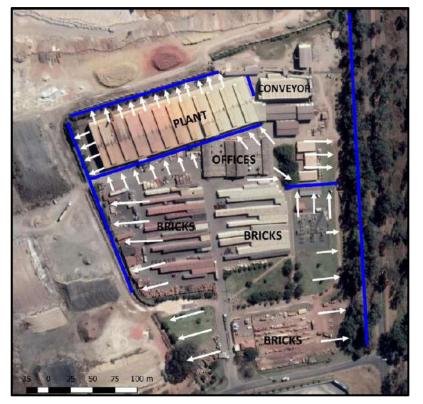
Figure 9: Existing Storm Water Structures

Existing storm water structures (concrete/earth channels) is illustrated in Figure 9.
